# A PRACTICAL GUIDE TO MAXIMIZING ROOF LIFE

# Stop Reacting. Start Planning.

# 10 Common Causes of Flat Roof Failures

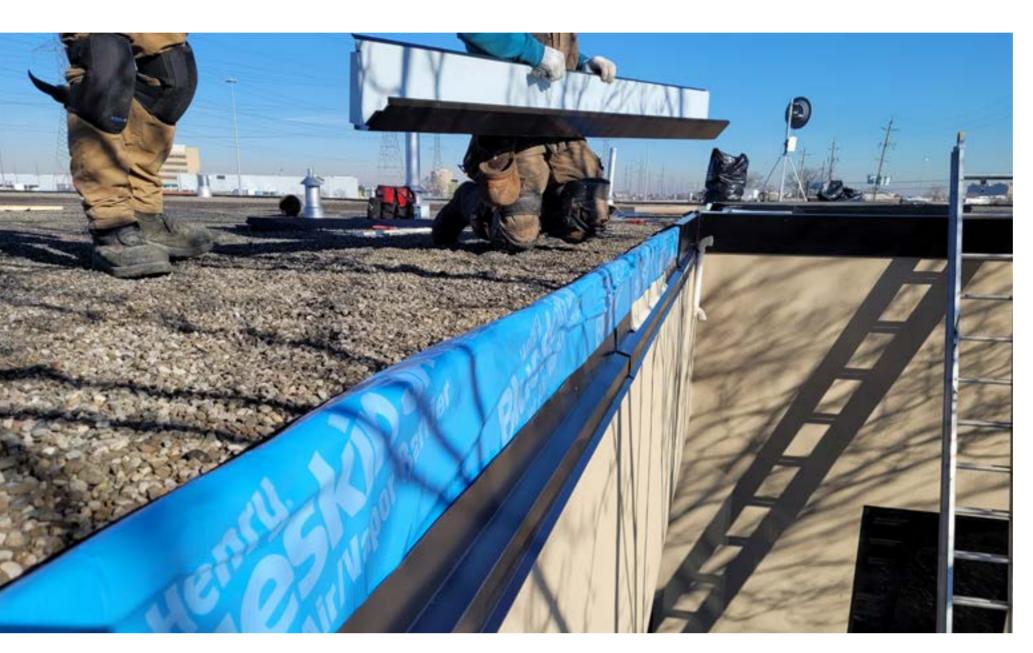
Issue #2. Flashing Failures		
Common in: BUR, EPDM, TPO		
Failure risk: Upgrade flashing details, inspect terminations regularly		
How to avoid:	Upgrade flashing details, inspect terminations regularly	
Early signs:	<ul> <li>- Most common leak origin point (parapets, penetrations, edges)</li> <li>- Often fails before the field membrane</li> <li>- Cracked or dried-out sealants</li> <li>- Flashing base not fully bonded to membrane</li> <li>- Improper termination heights below code (less than 8")</li> </ul>

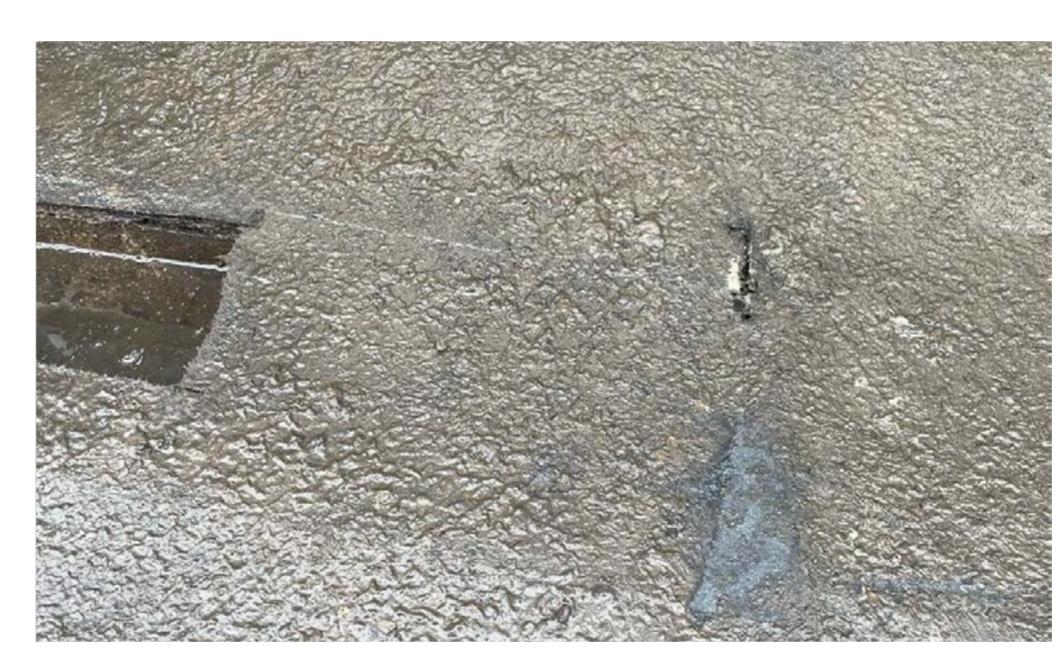
Issue #3. Foot Traffic & Mechanical Damage		
Common in: BUR (gravel hides damage), EPDM (puncture-prone)		
Failure risk: Cracks, punctures, membrane damage		
How to avoid: Install walk pads, train contractors, limit access		
Early signs:	<ul> <li>- Unprotected walkways or excessive foot traffic near units</li> <li>- HVAC panels or parts dropped during maintenance</li> <li>- Punctures from tools, screws, or debris</li> <li>- Membrane scuffs or surface abrasions</li> <li>- Ballasted systems with displaced gravel exposing membrane</li> </ul>

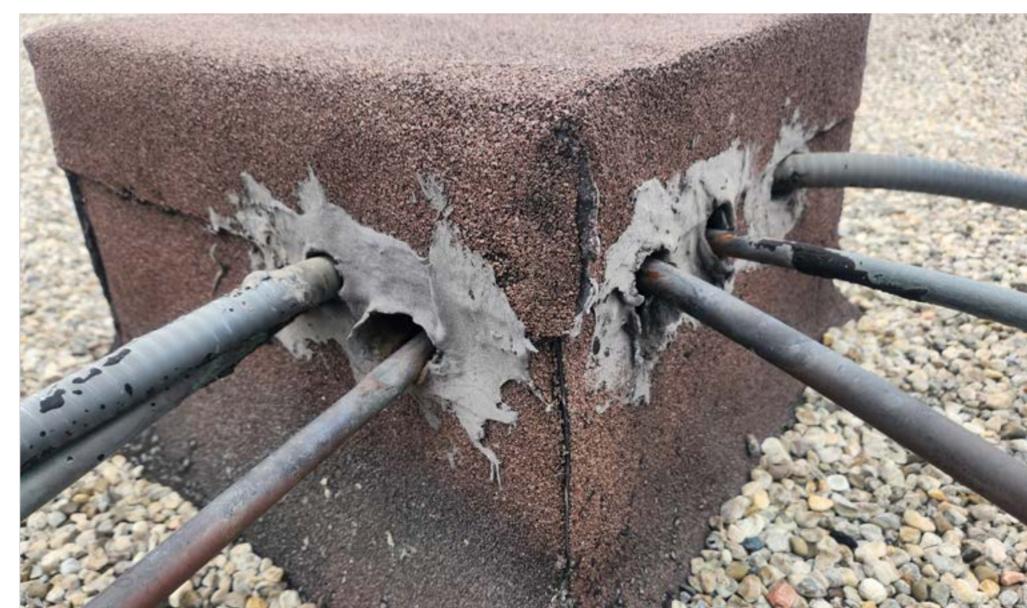
Issue #4.	Improper Repairs or Add-ons
Common in:	All systems
Failure risk:	Short-term fixes cause long-term failure
How to avoid:	Use compatible materials, always document history of repairs
Early signs:	<ul> <li>Incompatible materials used during patchwork</li> <li>Patching over wet insulation or old leaks</li> <li>Sloppy roof tie-ins with new mechanical equipment</li> <li>Flashings reused or bent out of position during repairs</li> <li>Caulking applied instead of membrane repair or welding</li> </ul>

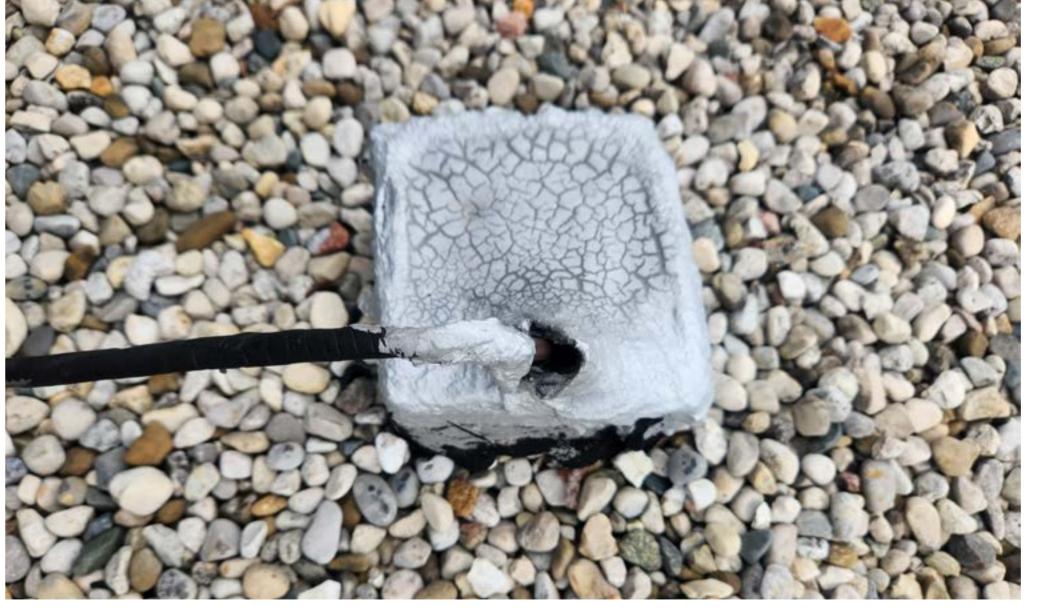
Issue #5. Pitch Pocket Failures		
Common in: All systems with pipes or conduit penetrations		
Failure risk:	Allows water to seep around penetrations, leading to interior leaks, wet insulation, and deck corrosion.	
How to avoid:	Use properly installed and sealed pitch pockets; inspect and reseal regularly as part of preventative maintenance	
Early signs:	<ul> <li>Cracked or dried-out sealant</li> <li>UV degradation of pitch pocket mastic</li> <li>Movement in conduit or unsupported penetrations</li> <li>Inadequate fill or shrinkage over time</li> <li>Improper or rushed installation during equipment add-on</li> </ul>

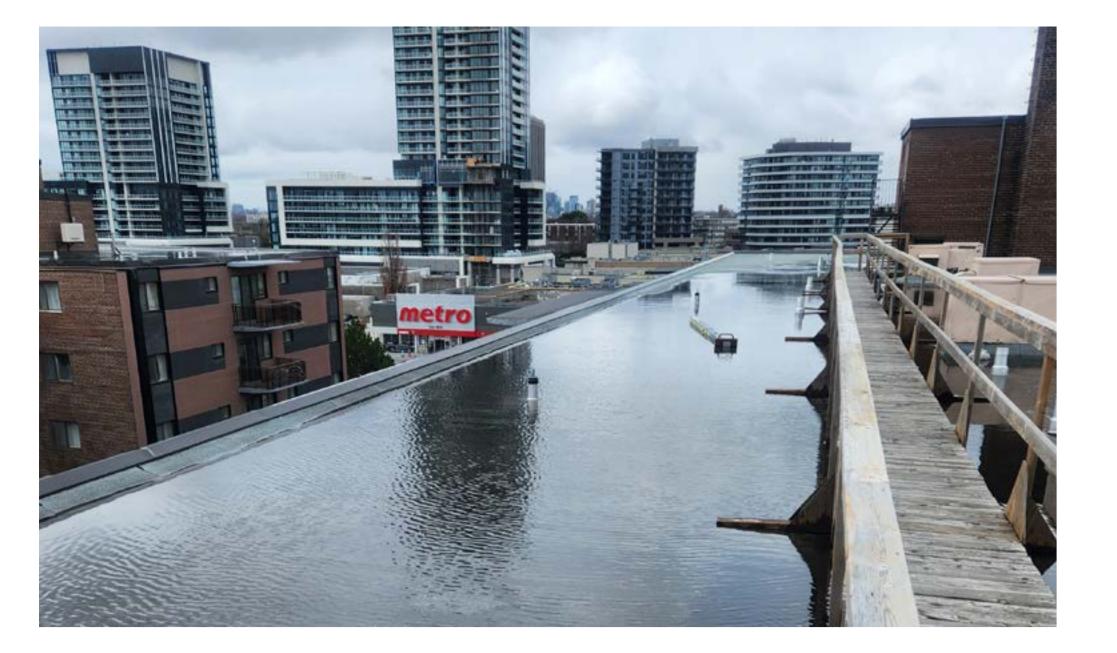
# Issue #6. Ponding Water & Poor Drainage

Common in: All systems, especially BUR & EPDM	
Failure risk:	Accelerates membrane breakdown, promotes organic growth
How to avoid:	Regular drainage checks, tapered insulation systems, added drains
Early signs:	- Water remains >48 hours after rainfall

- Flat areas with insufficient slope (<1/4" per foot)

- Low spots or "birdbaths" in the roof surface

- Blocked or undersized roof drains, scuppers, gutters

- Collapsed or compressed insulation causing depressions

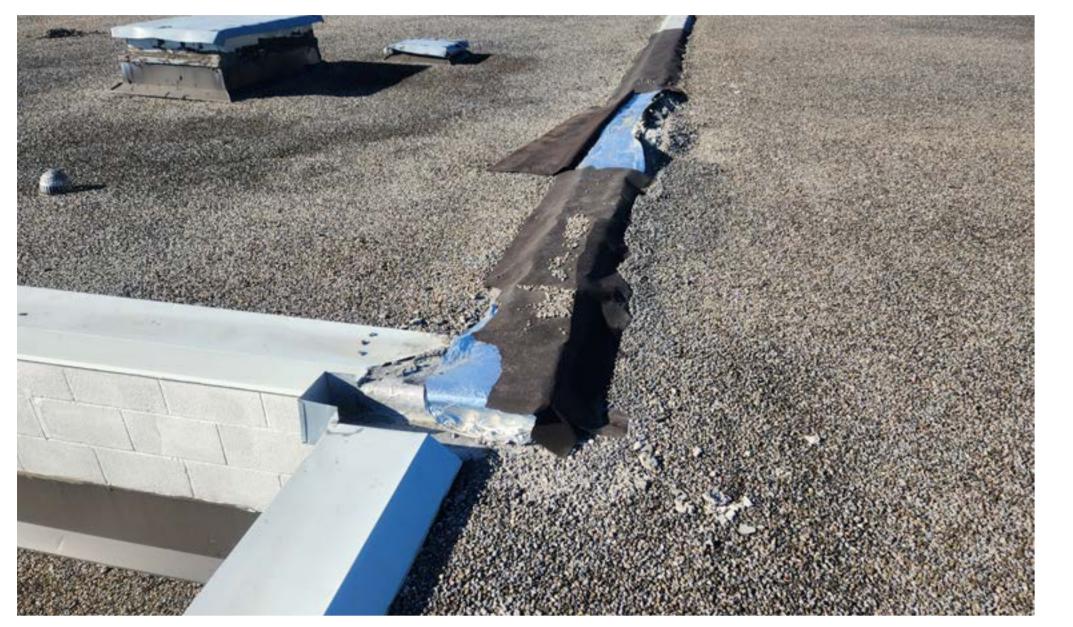
# Issue #7. Poor Workmanship

Common in:	EPDM, TPO, steel
Failure risk: Seam failure, splits, fastener pull-out	
How to avoid:	Expansion joints, flexible adhesives, re-tighten exposed fasteners (steel)
Early signs:	<ul> <li>Seams and flashing pull apart over time</li> <li>Steel roofs suffer from fastener loosening and panel shifting</li> <li>Gaps forming at terminations or penetrations</li> <li>Membrane wrinkling after cold nights or hot days</li> <li>TPO roof tents or pulls at corners and walls</li> </ul>

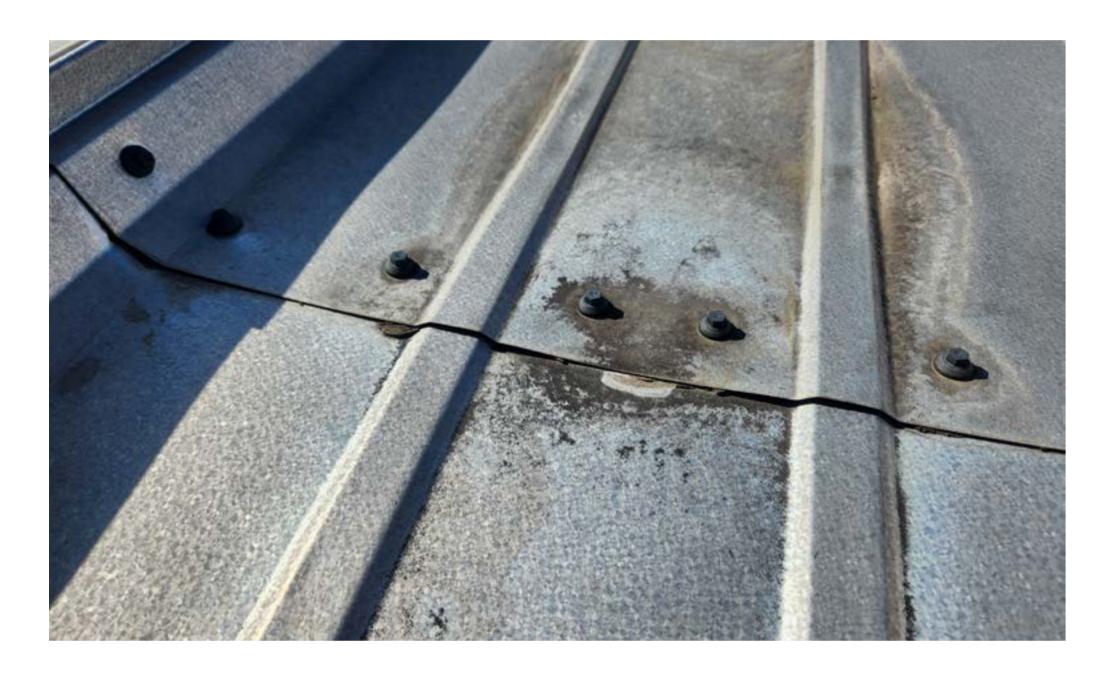
# Issue #8. Thermal Expansion & Contraction

Common in:	EPDM, TPO, steel	
Failure risk:	Seam failure, splits, fastener pull-out	
How to avoid:	Expansion joints, flexible adhesives, re-tighten exposed fasteners (steel)	
Early signs:	<ul> <li>Seams and flashing pull apart over time</li> <li>Steel roofs suffer from fastener loosening and panel shifting</li> <li>Gaps forming at terminations or penetrations</li> <li>Membrane wrinkling after cold nights or hot days</li> <li>TPO roof tents or pulls at corners and walls</li> </ul>

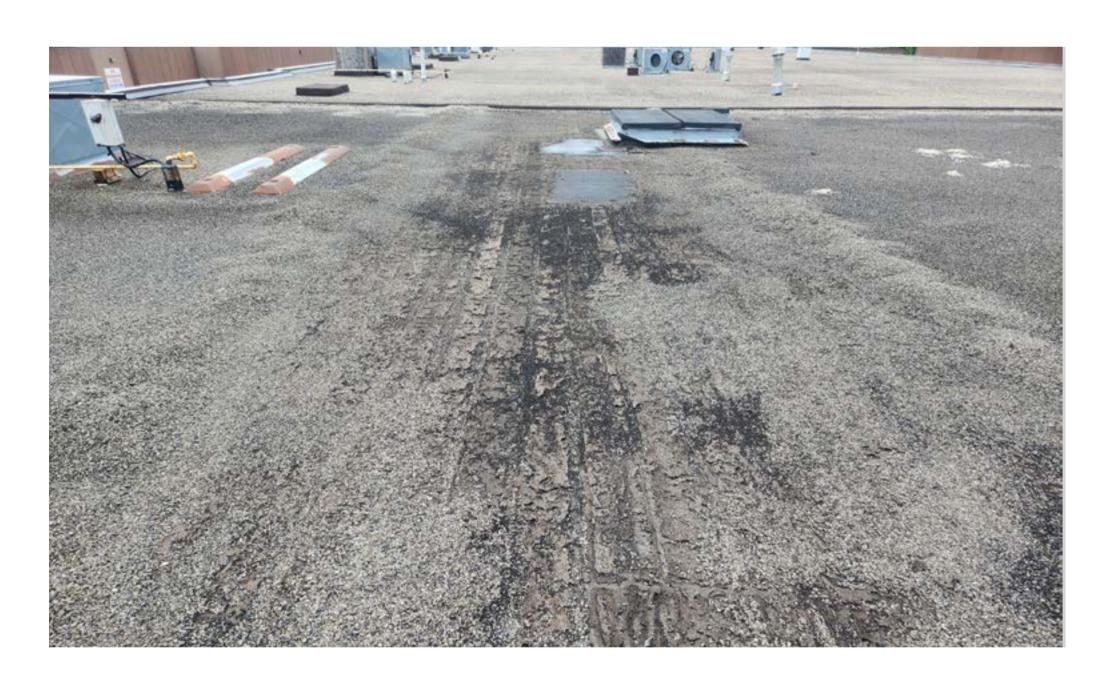
# Issue #9. UV Degradation & Weathering

Common in:	EPDM (most vulnerable), TPO	
Failure risk:	Loss of flexibility, brittleness, cracks	
How to avoid:	Use of UV-resistant coatings (acrylic or silicone), periodic inspections	
Early signs:	<ul> <li>EPDM is prone to chalking, cracking, and shrinking</li> <li>TPO seams may deteriorate faster in high UV areas</li> <li>Membrane discoloration or fading</li> <li>Cracking or splitting near protrusions</li> <li>Dry, brittle feel to the membrane surface</li> </ul>

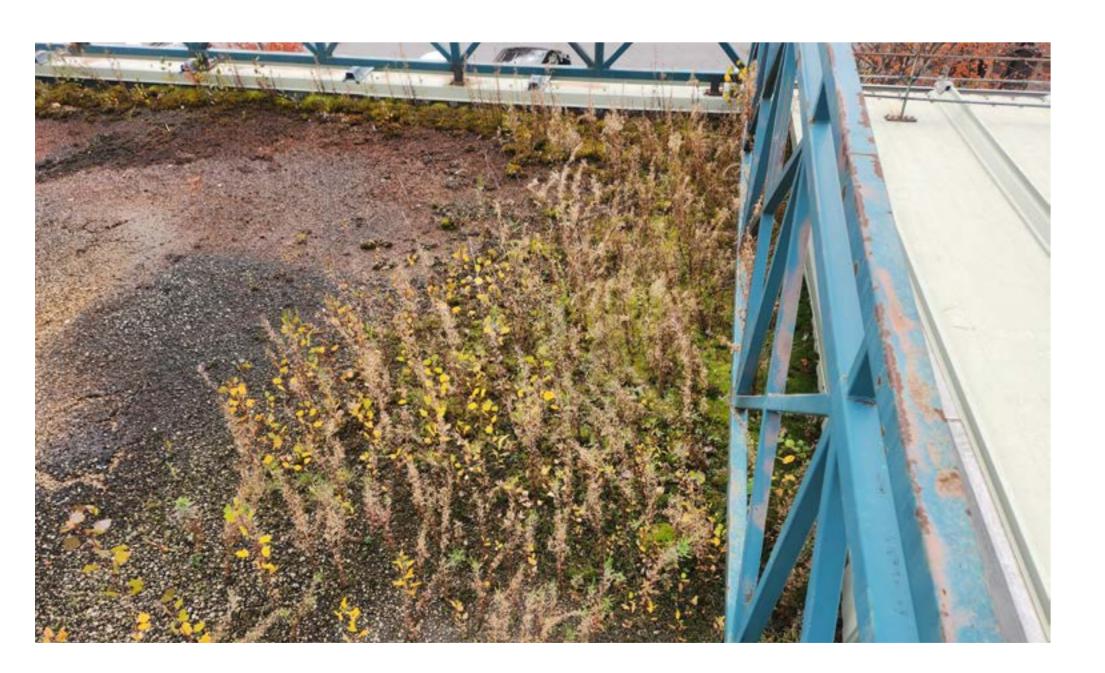
# Issue #10. Vegetation Growth

Common in:	Neglected flat roofs with standing water or debris buildup
Failure risk:	Roots can puncture membranes, clog drains, retain moisture, and accelerate material breakdown
How to avoid:	Clear debris regularly, especially near drains and corners; remove early moss or plant growth on sight
Early signs:	<ul> <li>Accumulated leaves, soil, or organic debris</li> <li>Moss or grass growing near drain outlets or ponding zones</li> <li>Standing water with algae or plant matter</li> <li>Poor housekeeping or lack of seasonal cleanups</li> <li>Rooftop HVAC or vents dropping debris that traps moisture</li> </ul>

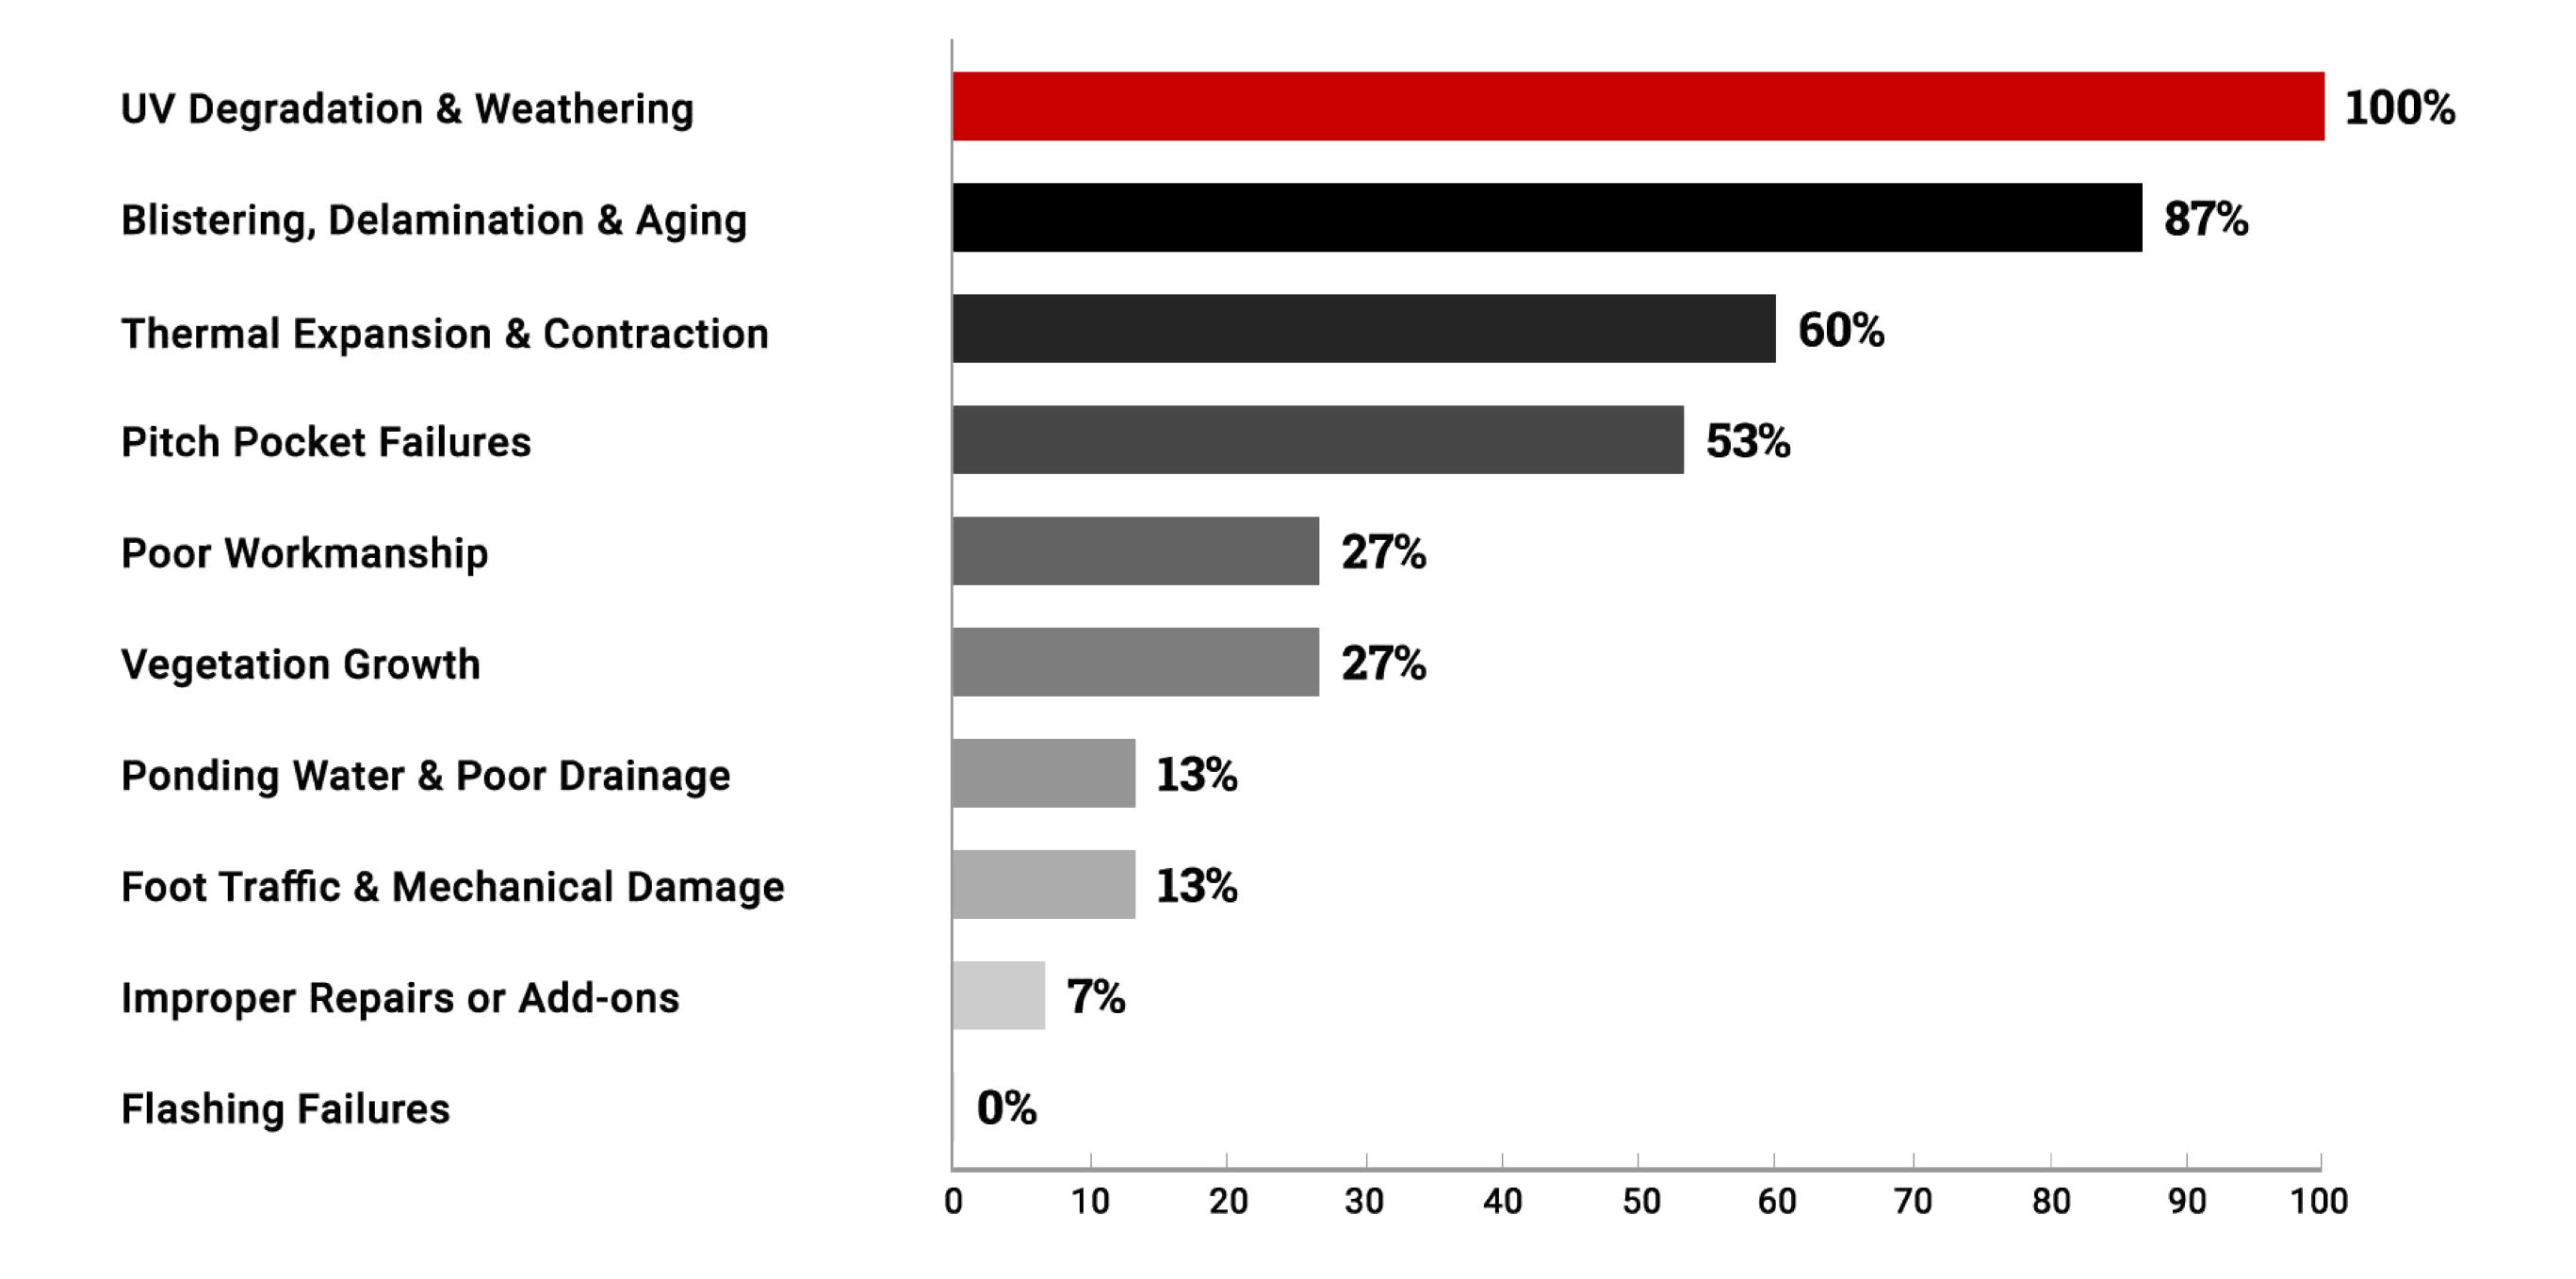
# Top 10 Flat Roof Issues in Ontario (2025)

Based on 58 real-world failures recorded across 15 commercial & industrial properties

n = 15 commercial and industrial properties assessed across Ontario. % = Percentage of properties affected by each recorded issue.

In our field analysis of 15 commercial and industrial flat roofs, we identified a total of 58 active failure points. Every property had at least three separate issues while most had four or more.

The most consistently observed issues were UV degradation (100%), membrane aging and delamination (86.7%), and thermal expansion and contraction (60%). Natural wear on a flat roof is expected over time, but these stressors become far more damaging when routine maintenance is absent.

Without early intervention, even manageable deterioration can accelerate into more complex failures such as pitch pocket breakdowns (53.3%), vegetation growth (26.7%), and ponding water (13.3%).
